Technical Memorandum BCWA

Date: January 27, 2016
To: Bear Creek Watershed Association
From: Russell N. Clayshulte, Manager
Re: BCWA TM 2015.03 Kerr Swede Gulches 2015 and Complete

Kerr/Swede Gulch E. coli Study

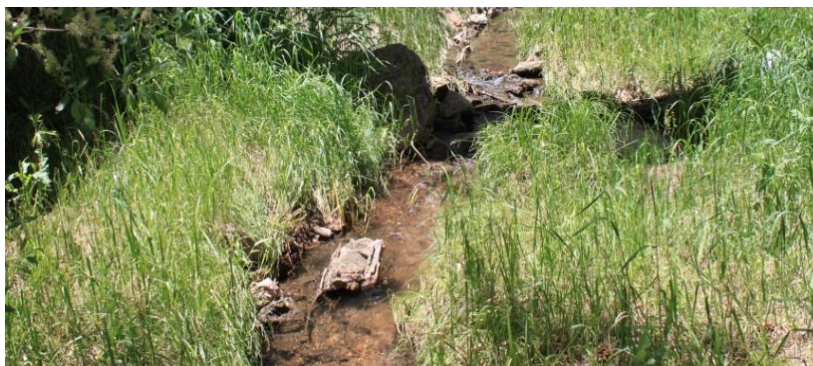
Figure 1 Sample Site at Kerr/Swede Confluence

The Colorado 303(d) list included Swede Gulch as a low priority for E. coli (Figure 1). The mainstem is Kerr/Swede Gulch with the western gulch upstream of the upper confluence as Kerr Gulch and the eastern tributary as Swede Gulch (Figure 2). Swede Gulch discharges into Kerr Gulch (Figure 3).

The Association monitored E. coli at 4-sites (Figure 1 and 2) from January (provided winter flows) through December. The Association also collected data for flow, temperature, pH, specific conductance and Dissolved Oxygen using the field probe and nutrient samples for laboratory analyses. The Association monitored nitrogen and phosphorus. The Association conducted the E. coli analyses. Table 1 shows the 2015 field data summary for Kerr/Swede Gulch sample sites. Table 2 shows the flow data. Table 3 shows the Geometric means for E. coli. The E. coli standard is 126/100ml (Measured as a geometric mean of data). There were no exceedances of the E. coli standard. Table 4 shows the nutrient concentration and load data.

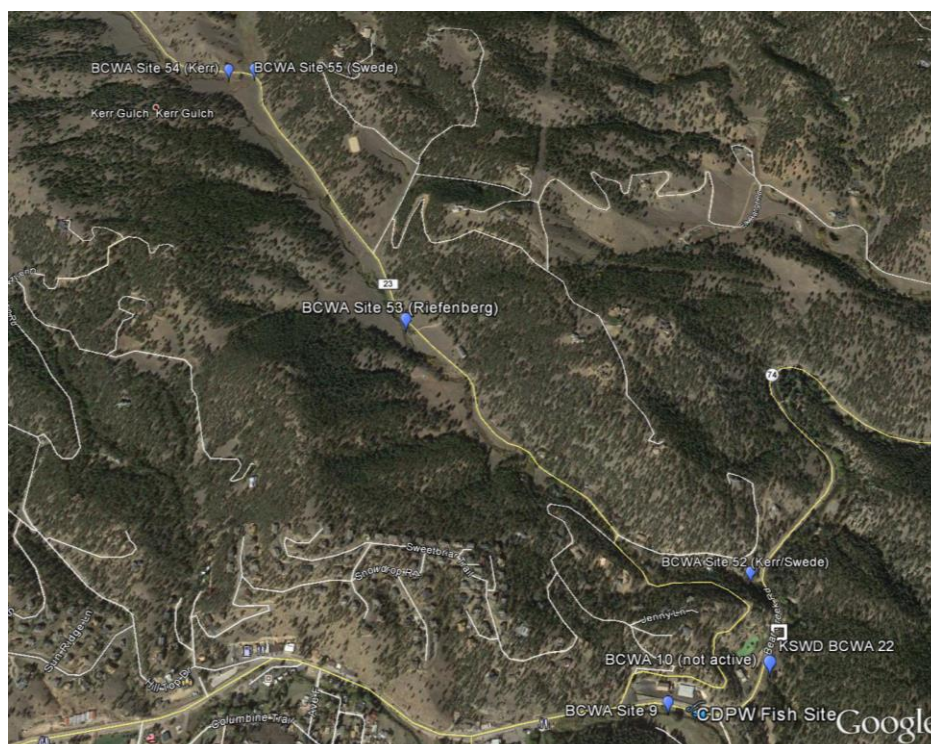
Figure 2 Sample Sites On Kerr Gulch

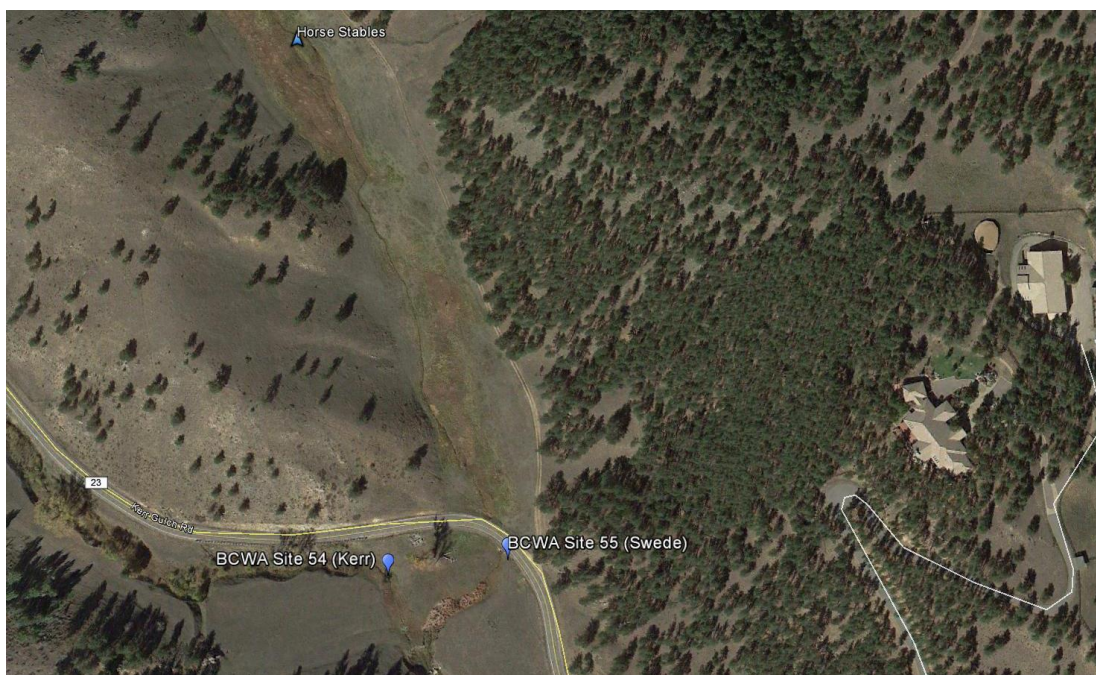
Figure 3 Swede Gulch Drains into Kerr Gulch

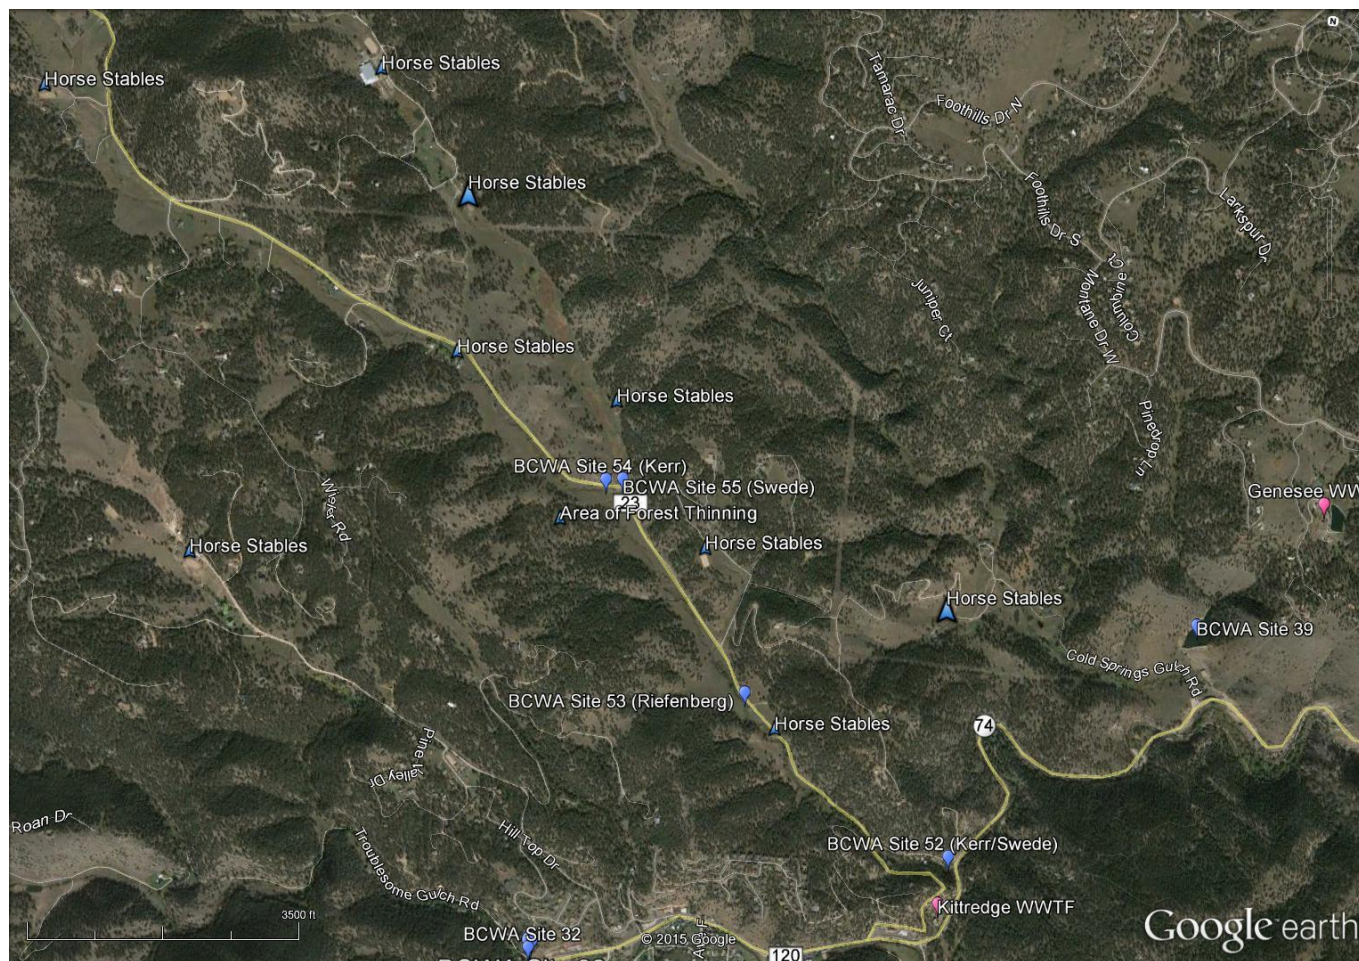
Figure 4 Horse Stable Operations in Kerr Gulch. There are at least 9 larger stable operations, with one facility on Swede Gulch that can house >45 horses.

The Division and Association agreed this area maybe a good candidate to understand the contribution of nutrients from septic systems and other land use practices (e.g., horse stabling operations) to the water quality in tributaries (Figure 4). The Division and Association agreed there is a water quality problem that requires further investigation. The Association completed the 6th year of a complete 5-year monitoring program to evaluate E. coli and nutrients on Kerr/Swede Gulch (confluence with Bear Creek, below confluence of Swede Gulch and just upstream of confluence on Kerr Gulch) and lower Swede Gulch.

The BCWA had conversations with several landowners and stabling operations. In the lower drainage, a horse stable on Kerr Gulch provided a stream buffer by moving the primary stabling area away from the stream. The owner was also willing to remove manure stockpiles immediately adjacent to Kerr Gulch. On Swede Gulch, the owner of a larger stabling operation voluntarily hauled off three trailers of manure reducing the loading potential of E. coli entering Swede Gulch. Jefferson County and the BCWA are currently exploring more options to address water quality degradation caused by stabling and grazing operations.

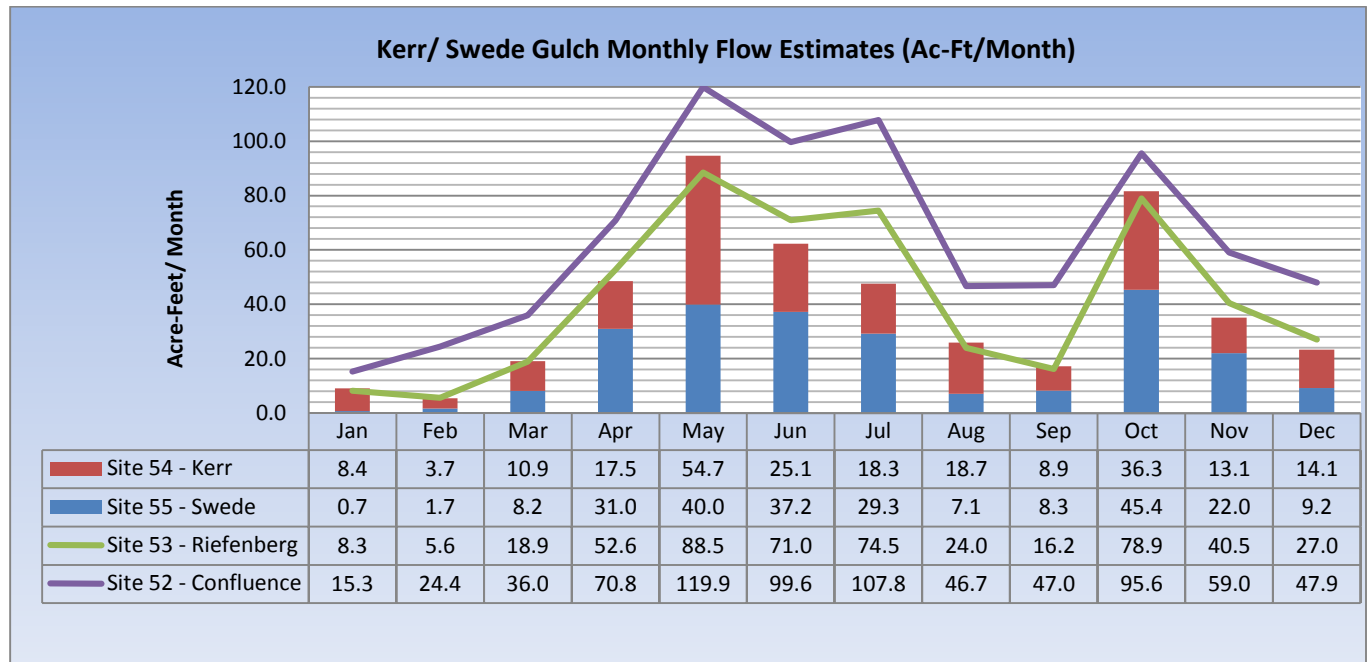
Figure 5 Flow Record

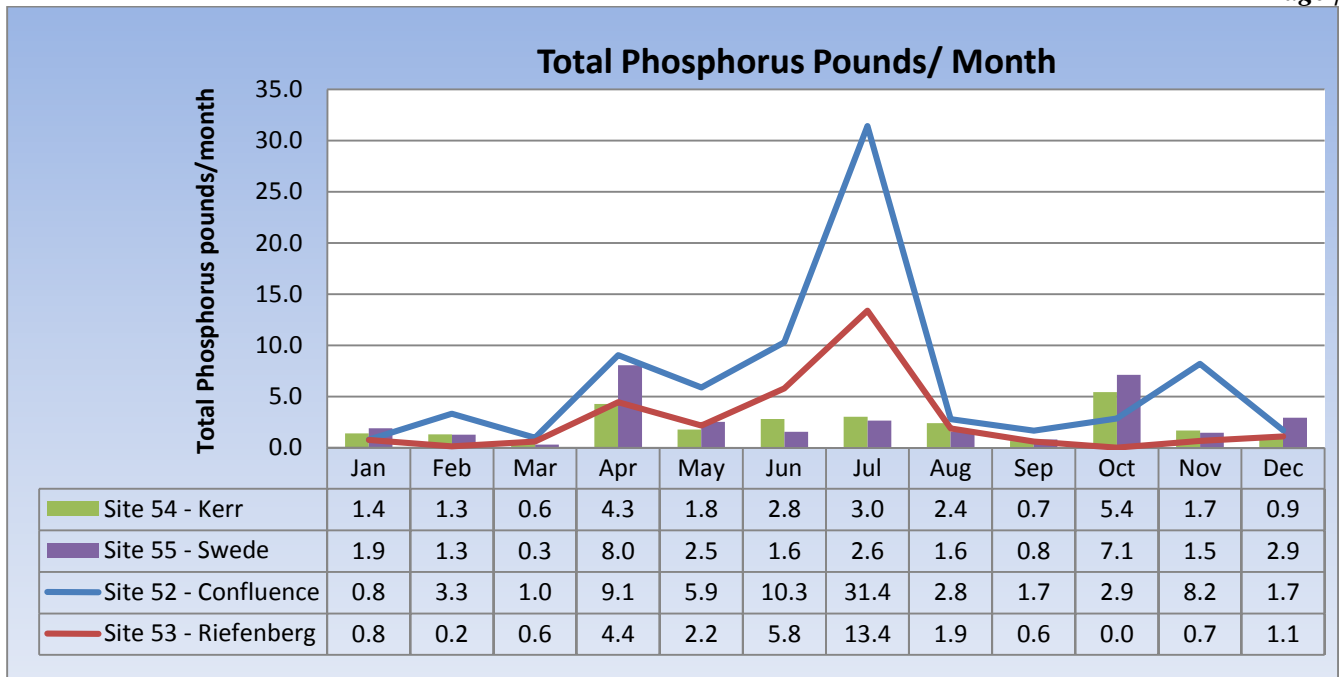
Figure 6 Total Phosphorus Loading

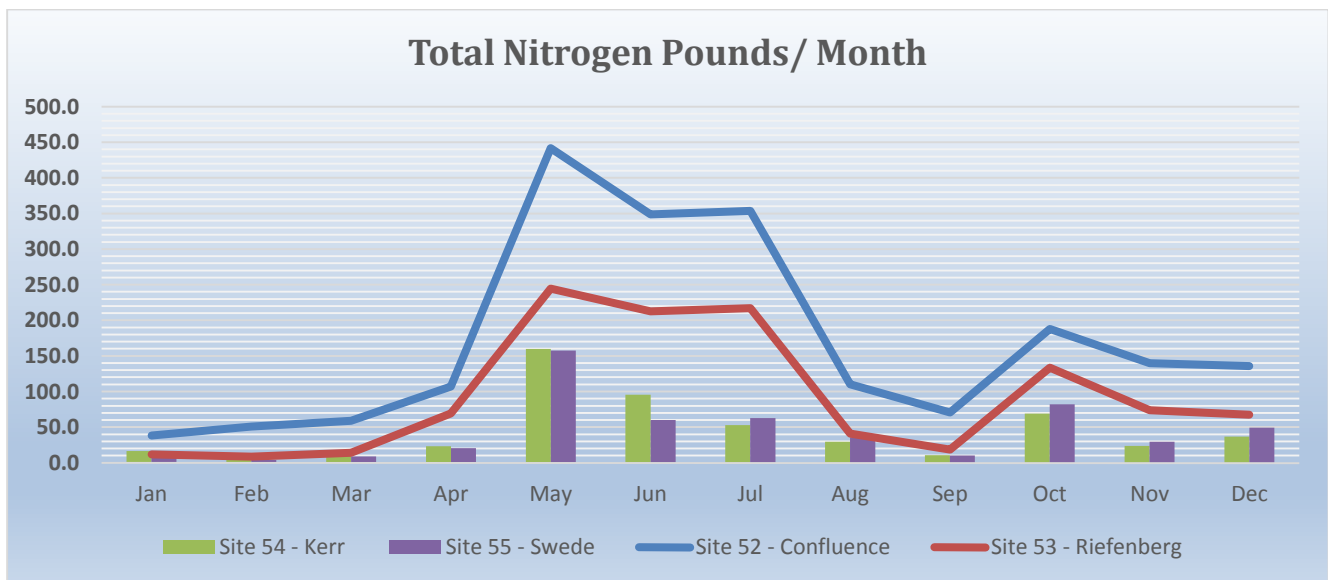
Figure 7 Total Nitrogen Loading
