# BCWA PINNACLE

Volume 2013.2

## Bear Creek Watershed Association, Colorado

### Water Quality Can Change After a Major Flood Event

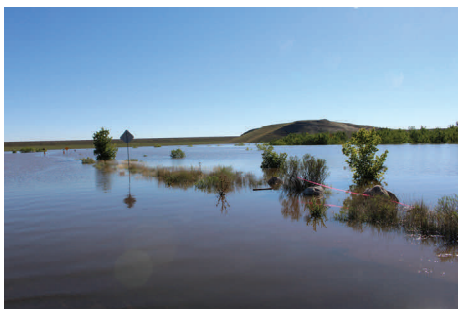
The picture from newsletter 2013.1 is the Bear Creek Reservoir at normal pool (2,000 ac-ft). During the great flood of September 2013, the pool increased to over 15,000 ac-ft and flooded some of the park roads, trails and recreation facilities.

Bear Creek Dam was the last of three dams built to protect the Denver region from floods. Located on the southwest edge of suburban Lakewood at the confluence of Bear Creek and Turkey Creek, construction of the dam was authorized in 1968 and was completed in 1982. The roll-earth dam was constructed in two segments including the main embankment and the south embankment. Bear Creek Lake is less than 1 mile long and has an average depth of 40 feet. The lake drains an area of approximately 236 square miles. The normal multi-purpose pool measures 110-surface-acres and has a storage capacity of 2,000 acre-feet.

In September 2013, the reservoir became a major flood control structure that prevented unimaginable downstream damage. The rains began in earnest on September 9, 2013 in the upper watershed and the resultant great Bear Creek flood has altered streams and reservoirs throughout the watershed. The U.S. Army Corps of Engineers shut the outflow gates on Bear Creek Reservoir on September 13, 2013. The pool rose from 1,817 acre-feet to over 15,000 acre-feet (5 trillion gallons) on September 22, 2013. The surface area was about 500 acres or 70% of surface acre capacity. Bear Creek within Bear Creek Park ran at about 40 cubic feet per second on September
