MEMORANDUM

Re: **Technical Memorandum 2012.02 - Sampling Program Summit Lake/ Denver Mountain Parks and National Forest Service lands and 2012 Water Quality Data and Observations**

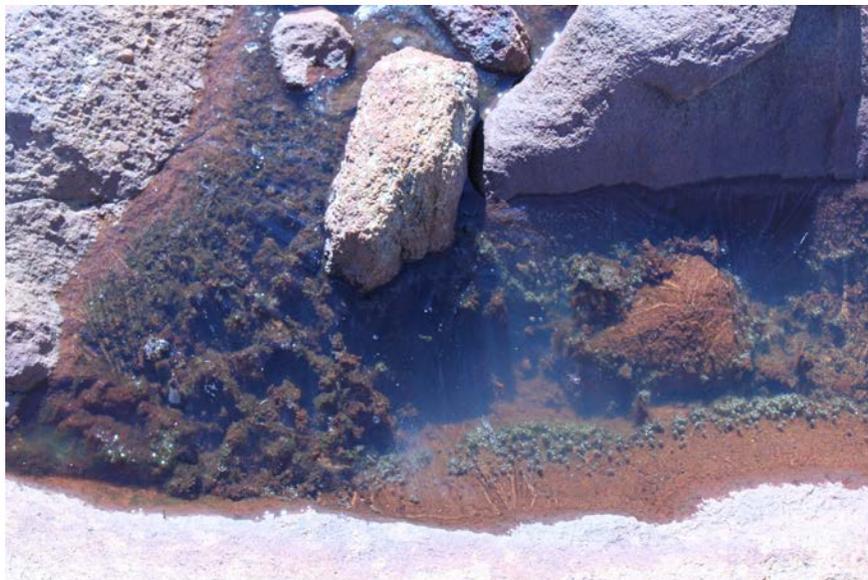
The limited 2011 water quality data suggested a nutrient pollution source in the area, but no site-specific monitoring was done to trace the potential pollutant source. The possible points of enriched nutrient water were photographed where they discharge into the small pond below Summit Lake (Figure 1) within the Bear Creek upper drainage. The discharge zone appeared to be about 25 feet across.

Figure 1 Growth in suspected flow plume into Bear Creek below Summit Lake

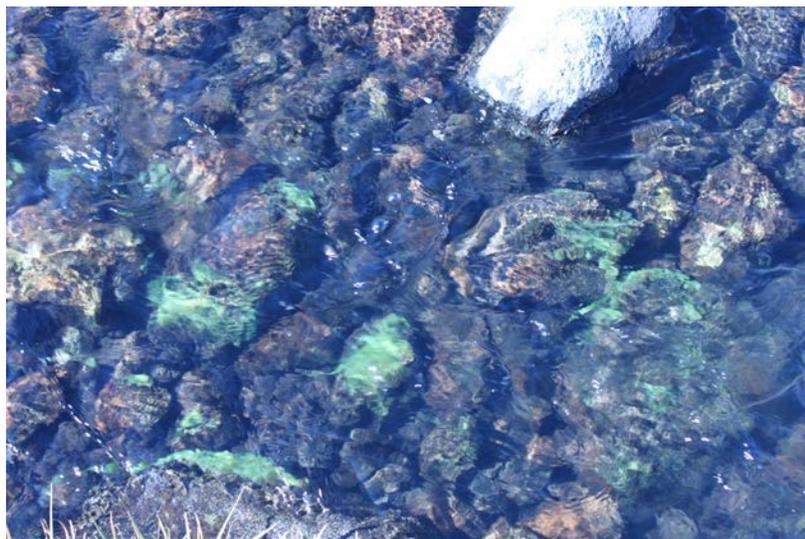
There was 90% to 100% periphyton coverage of the cobble substrate recorded for about ¼ mile of Bear Creek below the second pond on September 9, 2011 (Figure 2). At the BCWA site 36 sampling point in Summit Lake at the outfall pipes, the periphyton coverage was about 10%.

Figure 2 Bear Creek below Summit Lake with about 90% periphyton coverage and thick blue-black algae, September 9, 2011. Site elevation is about 12,000 feet. Several areas were noted with 100% periphyton coverage on cobble substrate. Once the algal matting established all fish in stream disappeared.

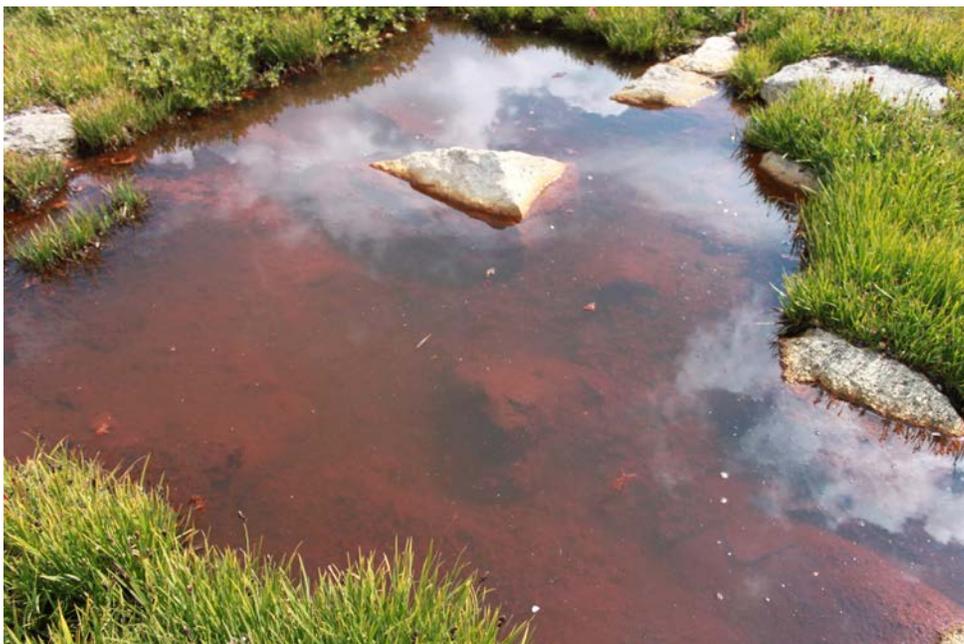
Figure 3 BCWA Site 61

2. BCWA Site 61 top of plume (Figure 3) across from the Summit Lake parking lot in a pond about 5X10-feet with a May depth of 20” and moderate orange algal growth covering 80% of pond substrate. In July pond depth was shallow. By August 2012 the orange algal growth about 6 inches thick and the pond had more water from surround drainage and rainfall. In September the red orange algal matting was about 12 inches thick with very little Dissolved Oxygen.

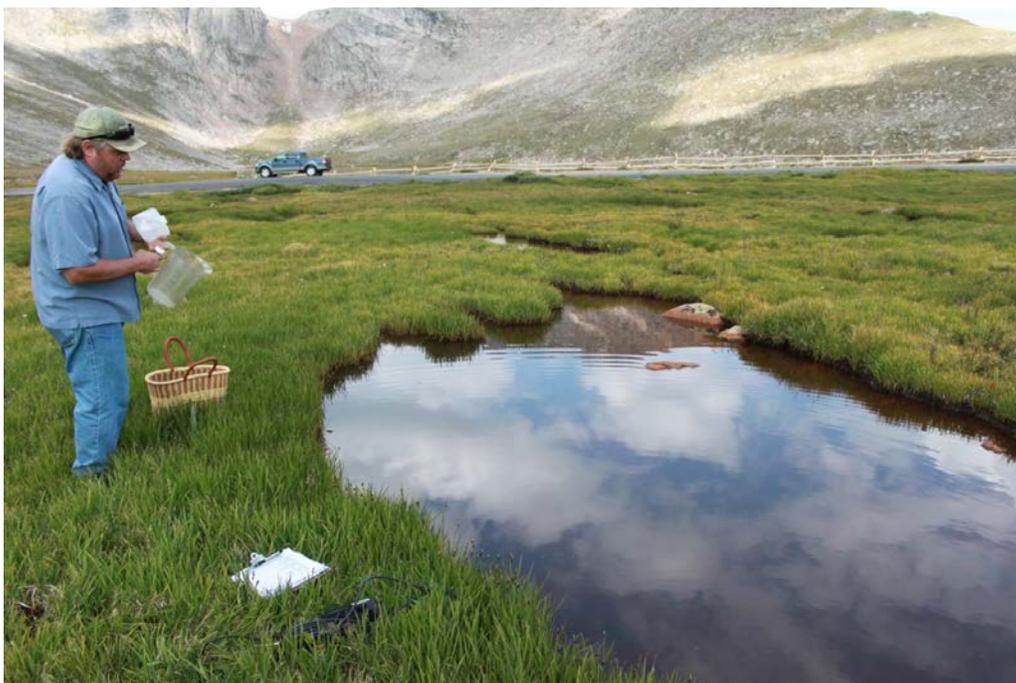
Figure 4 BCWA Site 62

3. BCWA Site 62 middle of plume about ½-way to point of discharge into lower pond (Figure 4) about 8X20-feet with a May depth of 20” and moderate orange algal growth covering 75% of pond substrate. In July pond depth very shallow, area drying out with red-orange algal growth. By August sampling much more water (as seen in Figure 4) with 18” depth and very extensive red algal growth. Noted dead moths and other insects. In September the pond was about 16 inches deep with reduced red and green algal growth, and appeared to have gotten some rain/snow input (dilution).

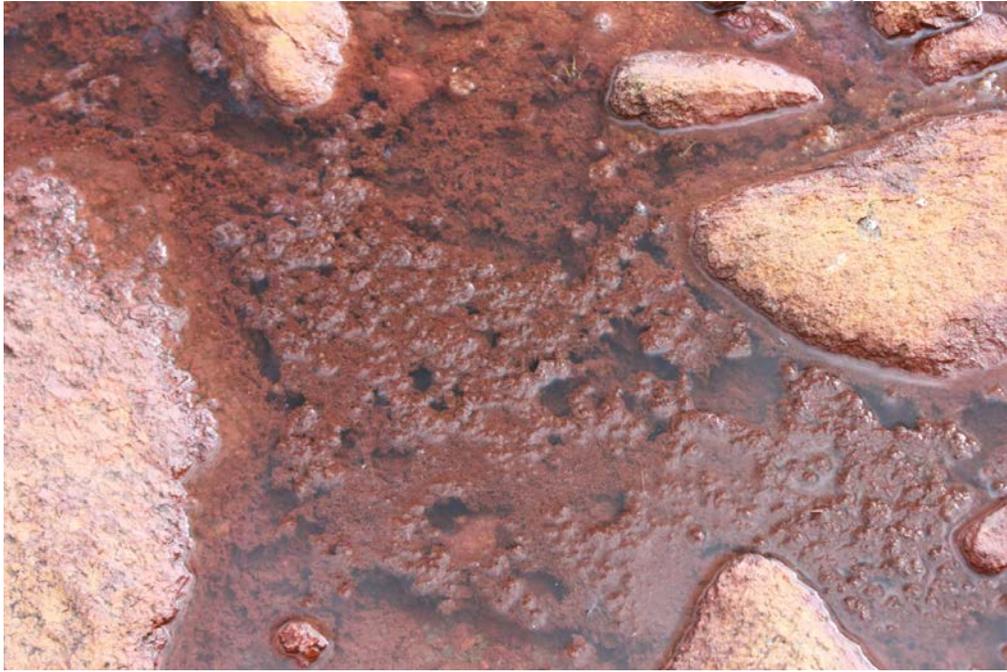
Figure 5 BCWA Site 63

4. BCWA Site 63 bottom of plume at discharge point into lower pond (Figure 5) with dispersed flow zone about 20-feet wide, area contains red algae covering about 95% of substrate. There are about 6 places where plume flow appears to enter the first pond below Summit Lake (See Figure 6). There is one major marshy area inflow point that enters Bear Creek above the first pond, but this discharge appears to be more surface runoff that originates east of the park area. The Association only selected the middle pond within the “groundwater” discharge zone. In early June this site had the most flow. Smaller flows were observed in July and August. This flow path also has the thickest algal growth and the most algal growth in the adjacent first pond. However there are other nutrient loading points from the in-flow zone. In September the plume runoff had reduced flow at the monitoring site, but the inflow zone was noted to be about 25 meters across and 14 separate inflow zones were noted.

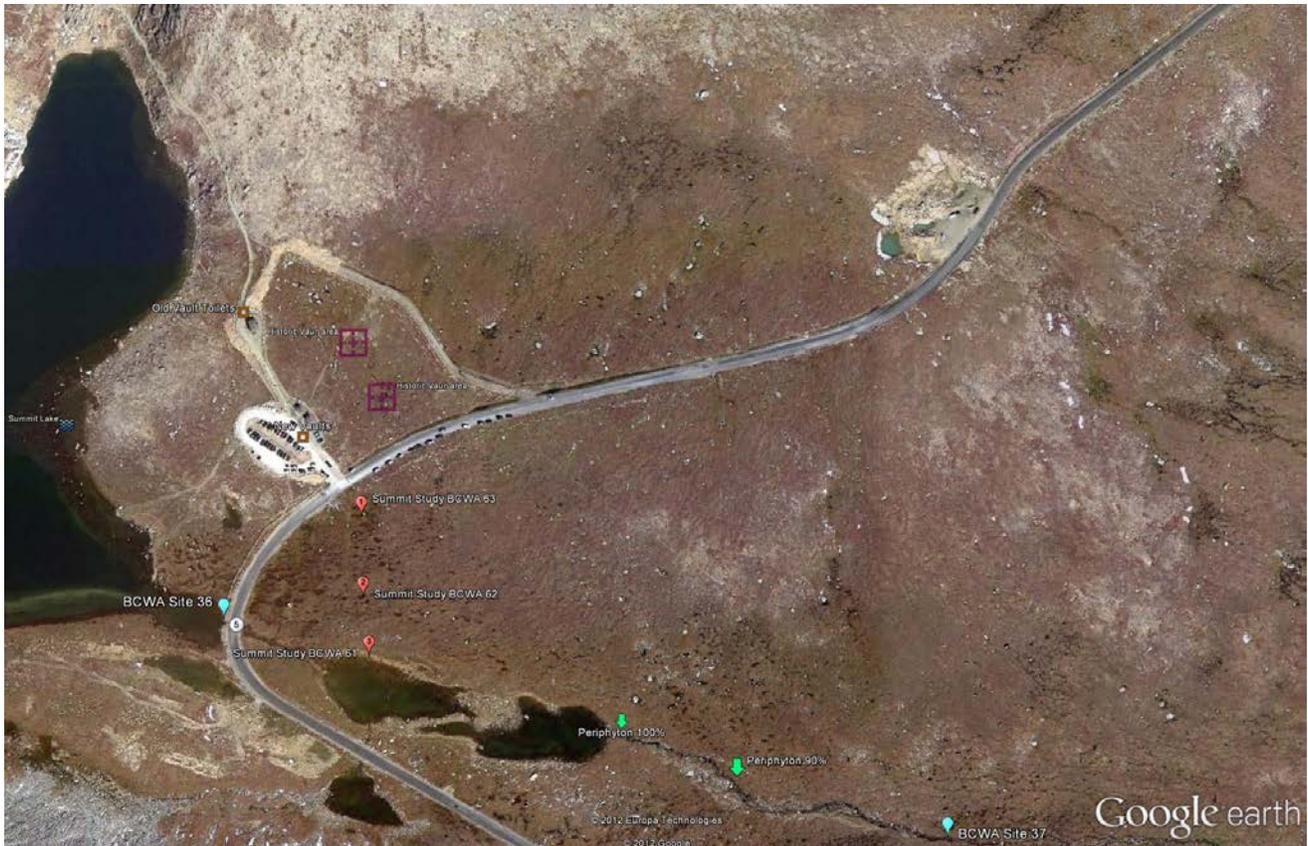
Figures 6 and 7 shown sampling area and suspected plume origin. Historic practice left septic waste on site in a pit privy or vault. The parking lot now has relatively new “water tight” waste vaults, which are periodically pumped and hauled to the Metropolitan Wastewater Reclamation plant in Denver, according to information provided to the Association.

Figure 6 General Summit lake Parking area and suspected plume path

The Association strongly believes it is necessary to install several lysimeters adjacent to the vaults and along the suspected flow path for additional water quality testing. There needs to be further study to determine the extent, concentration and movement of the plume to understand and minimize future fish kills and environmental effects associated with the pollution plume. The low pH, low dissolved oxygen and elevated ammonia-nitrogen associated with the pollution plume are likely contributing to or directly producing the fish kills and degrading habitat.

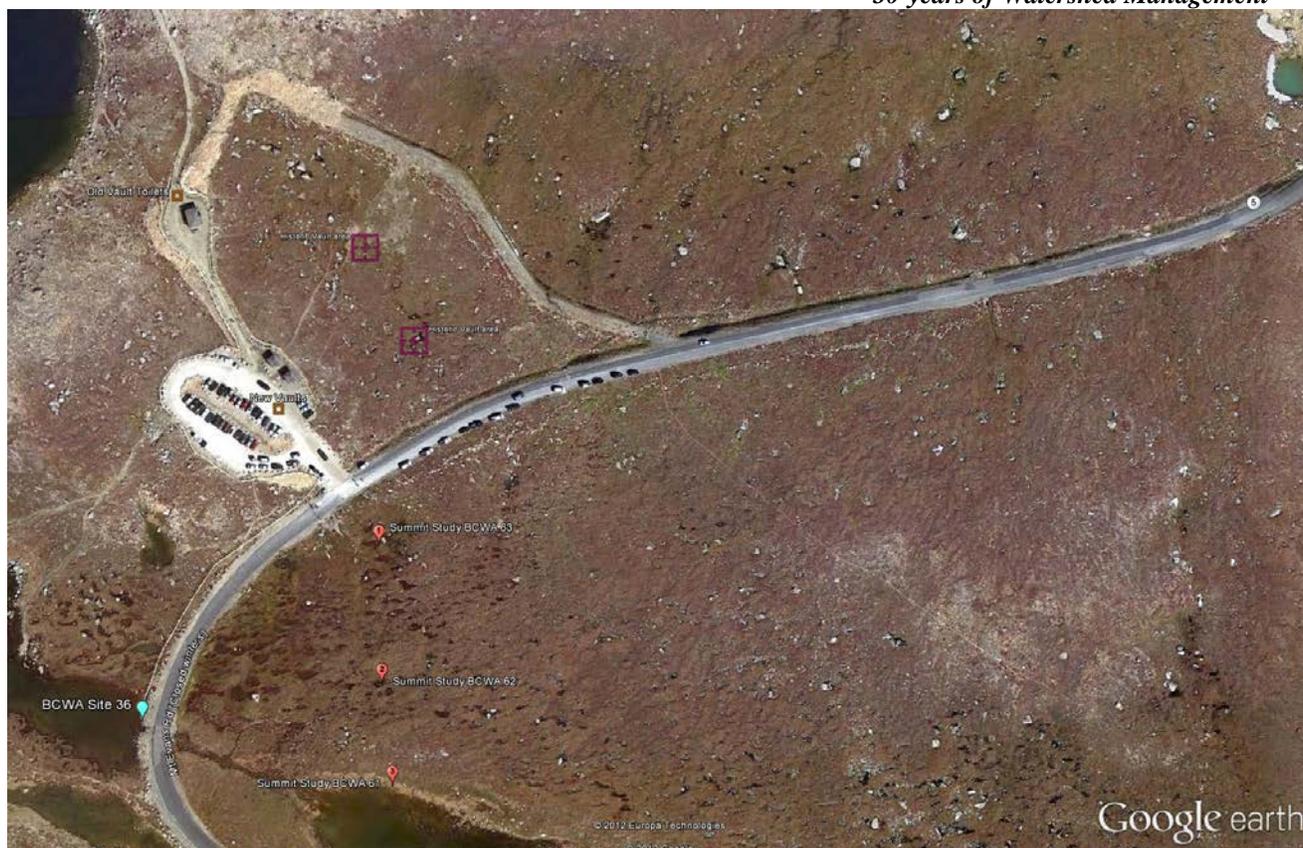
Figure 7 Note heavy car presence at parking lot and on road

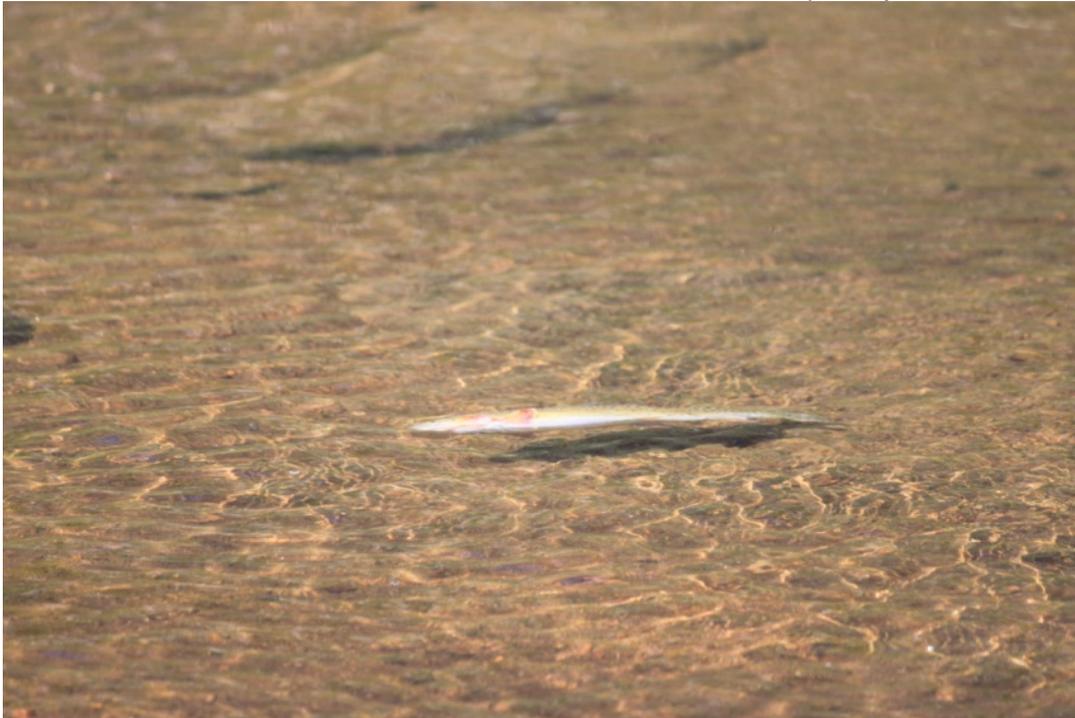
Figure 8 **Dead Fish in Bear Creek**

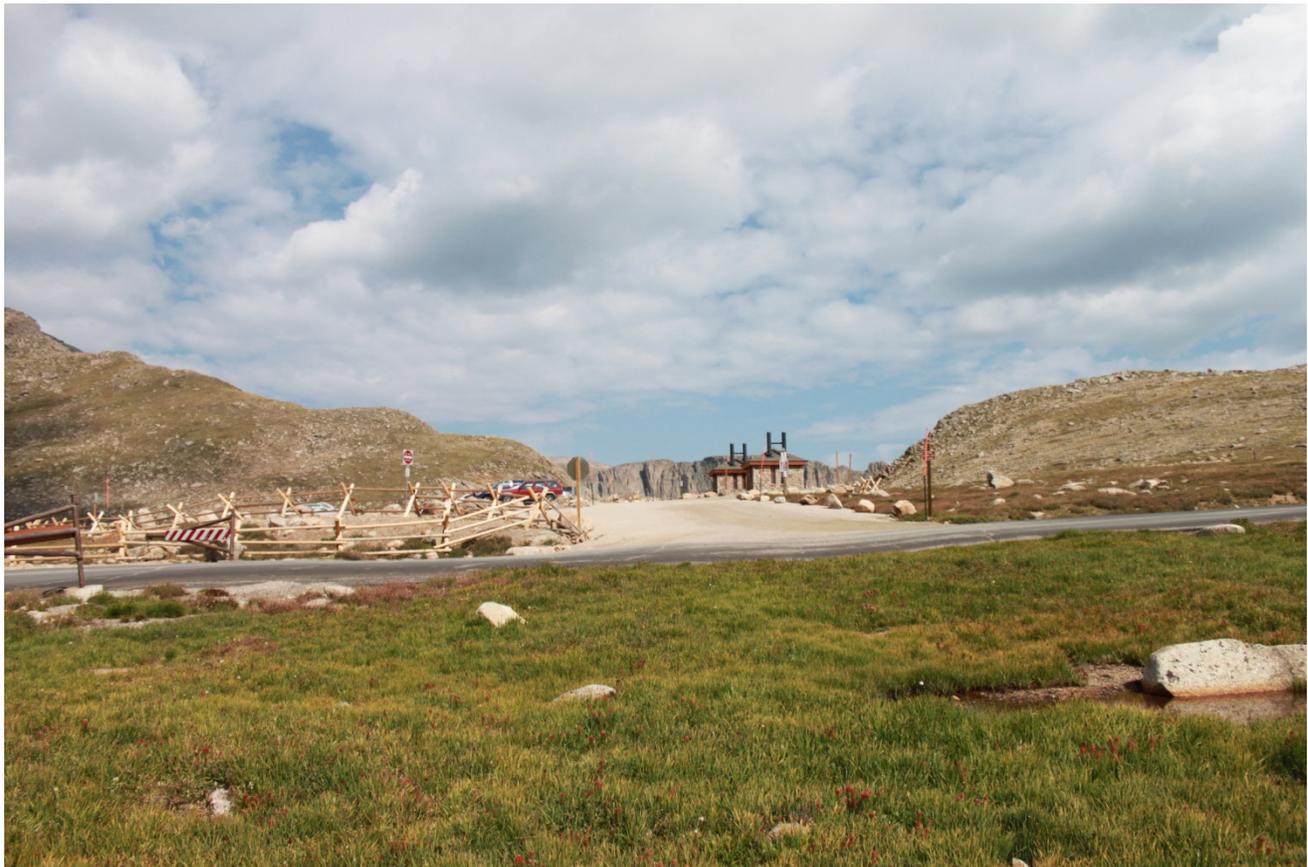
Figure 9 **Summit Parking Lot and Suspected Flow Plume Origin**

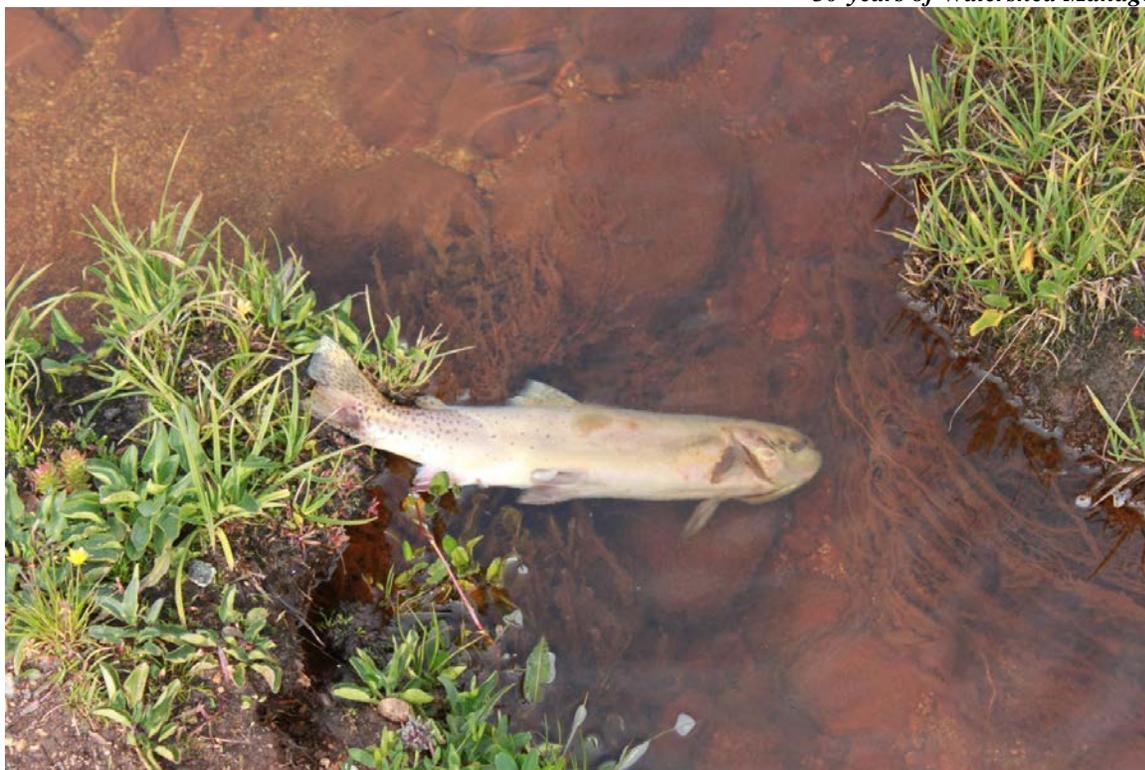
Figure 10 Large Dead Fish 8-10-12

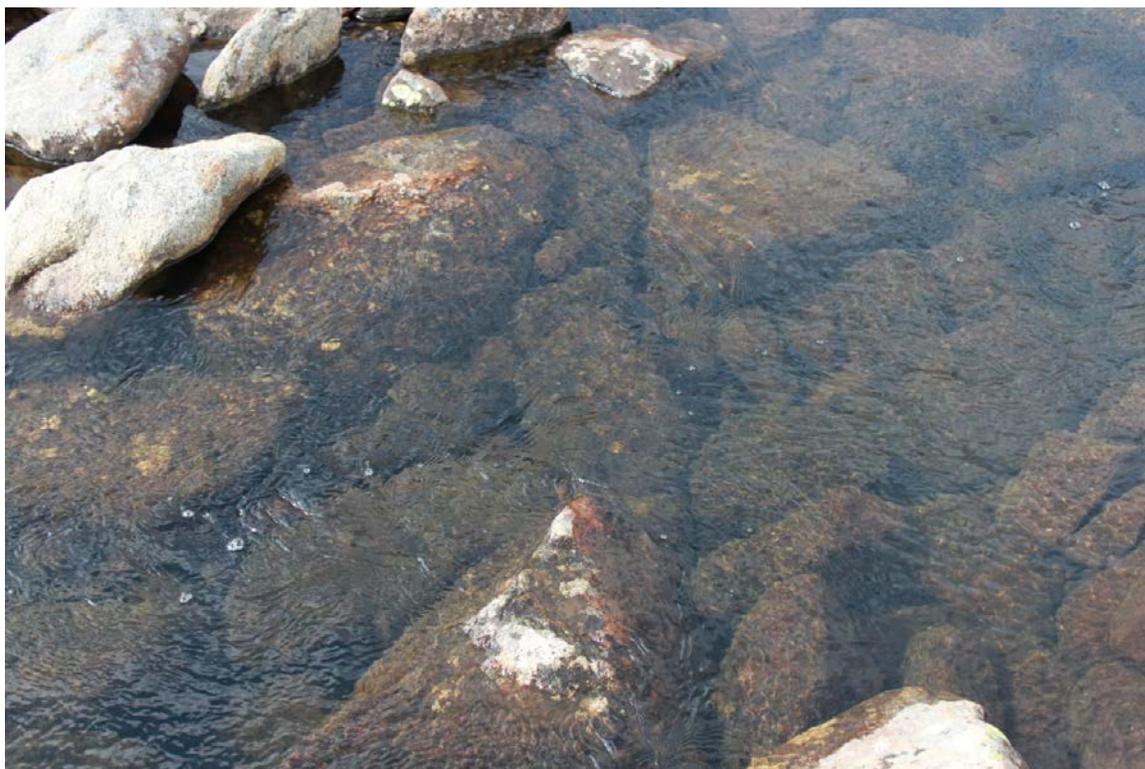
Figure 11 95% periphyton cover of substrate

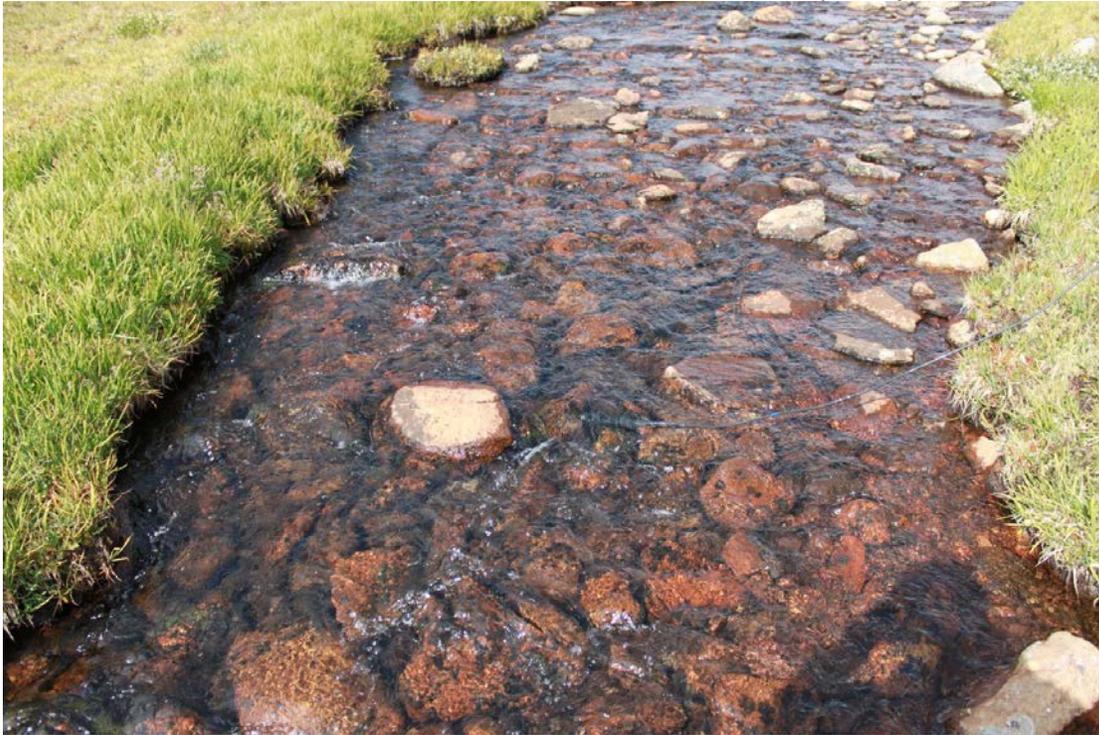
Figure 12 BCWA Site 37

8/10/2012 – Western men’s and women’s vaults remain over ½ full with solids and very little liquid waste; while the 2-western vaults have more liquid content. Marshy area south of parking lot much wetter than last sampling with most ponds mostly full. Replicated sampling ponds from 7/13/2012 sampling. Definite increase in orange algal matting with thick bottom deposits. Difficult to trace plume flow path or pinpoint source origin. However, there is drainage from parking lot area (Figure 9). No live fish observed below summit lake culverts down to site 37. Large dead fish at plume mouth (Figure 10). The blue-black algal growth in upper Bear Creek below second pond was about 95% cover of substrate with long green filamentous algae common (Figure 11). At BCWA Site 37, the periphyton coverage had decreased to about 20-25% (Figure 12). BCWA Site 60 in Summit Lake had no periphyton cover of substrate (Figure 13).

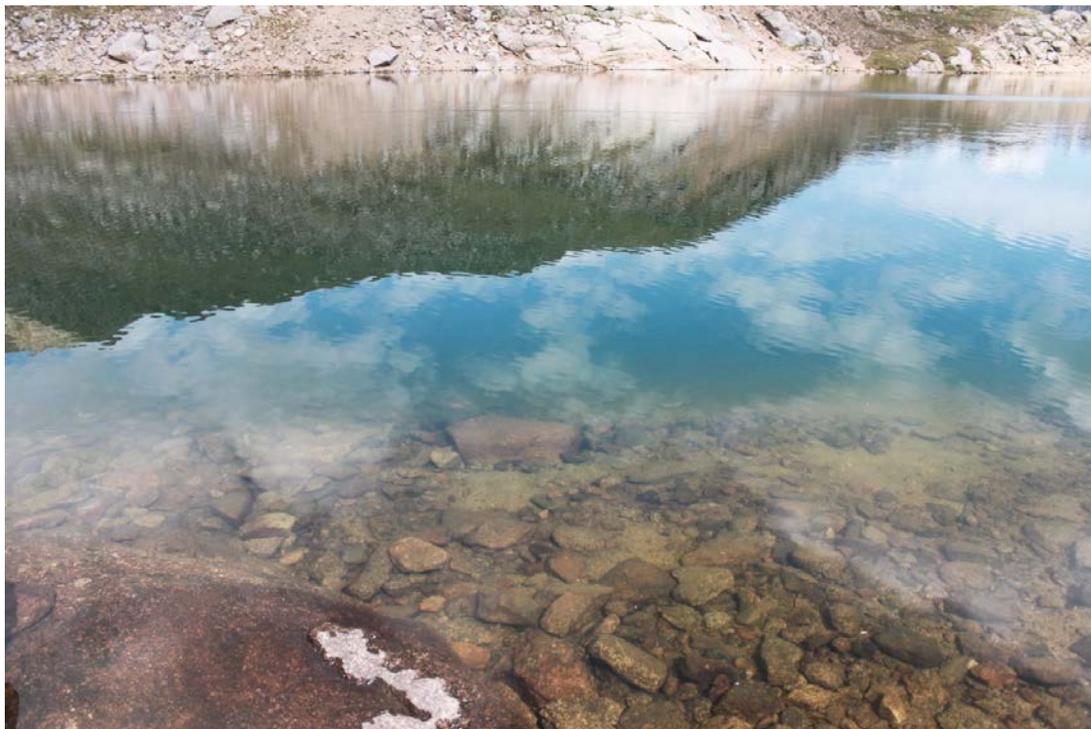
Figure 13 BCWA Site 60 in Summit Lake had 0% periphyton coverage in August 2012

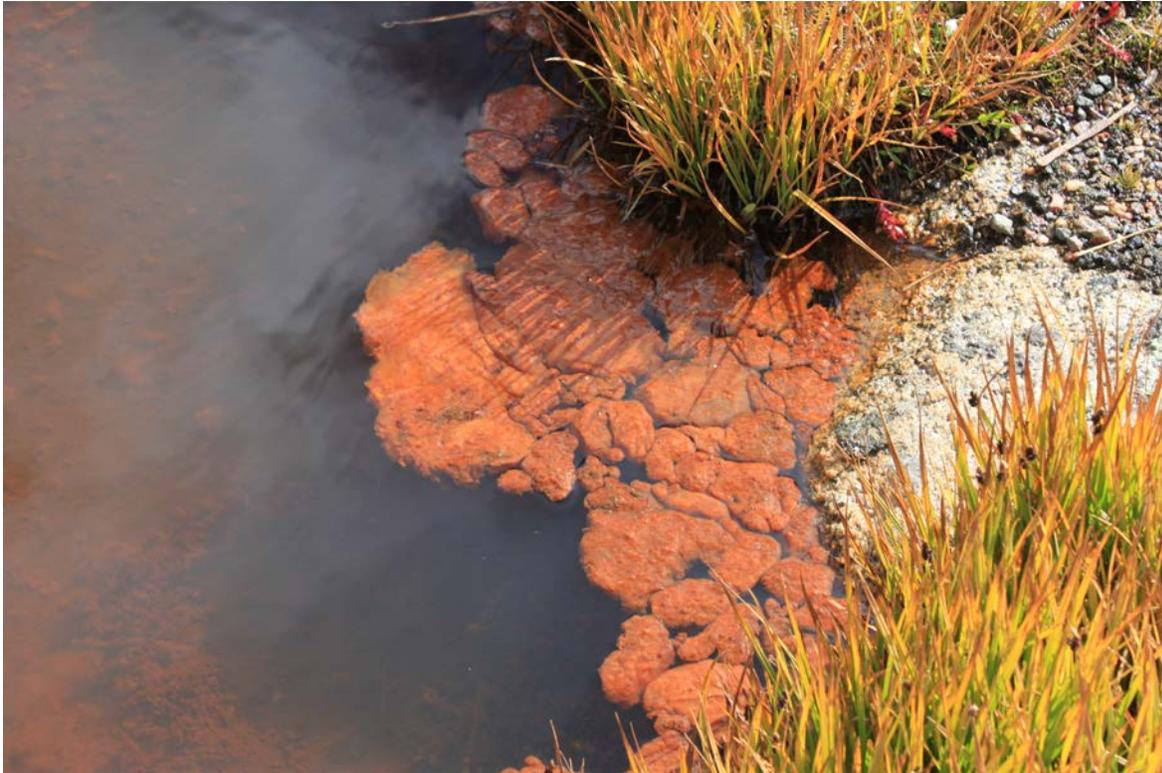
Figure 14 Orange algal growth in site 61 pond September 2012

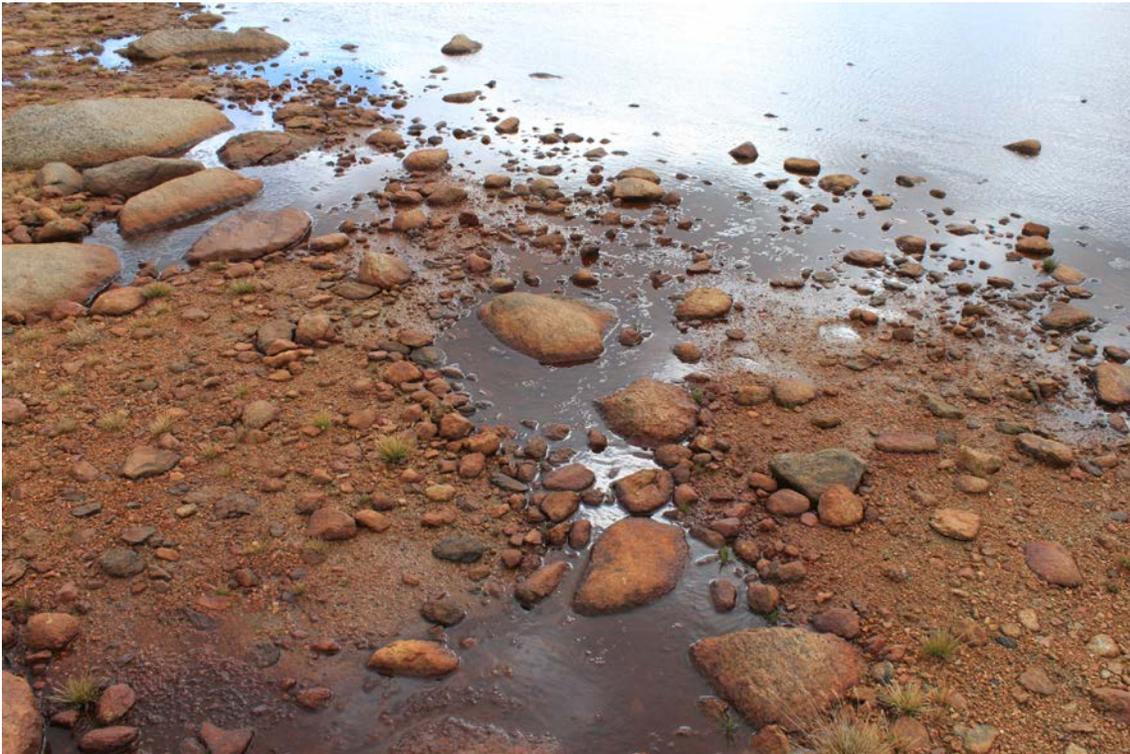
9/6/2012 – The vaults were closed for the year and the women’s vault had been pumped clean. The men’s vault was still filled with mostly solids and little visible liquid waste. The Association was informed that the women’s vault would undergo a leak test, which was simply to fill the vault with water and hand measure the water level. The snow fall that occurred from the day before monitoring had mostly melted and the runoff from this event had generated new surface flow into sites 61 and 62. Figure 14 shows the very thick orange algal that covers the pond to about 12 inches and clumped on the surface. Fish were observed in Summit Lake at both sites 60 and 36. These fish were healthy and not stressed. There were no fish observed in Bear Creek below the Summit Lake culverts. . In September the plume runoff was reduced to about 2-3 gallons per minute at the monitoring site, but the inflow zone was noted to be about 25 meters across and with a minimum of 14 separate inflow point/zones were noted. As such, the inflow plume was about 0.5 cfs. The algal growth had extended 3-4 meters into the bigger Bear Creek Pond. Figure 15 shows the plume inflow points into the upper bear Creek pond.

Figure 15 Inflow points into Upper Bear Creek September 2012
