Bear Creek Watershed Association

2018 Annual Report

Adopted May 10, 2019

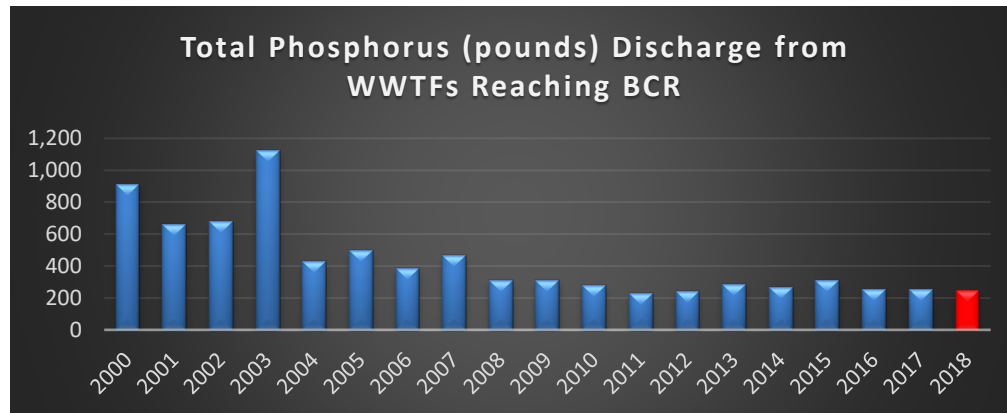
Figure 5 Point Source Load Reaching BCR

The point source load of total phosphorus in 2018 (Table 1) was 990 pounds. The estimated nonpoint source load in Bear Creek above the Harriman Diversion was about 1,000 pounds with about 50% of this load diverted into the Harriman Diversion. On average over 18 years of data record, only about 30% of the total phosphorus load reaching Bear Creek Reservoir is attributable to point sources (Figure 5). Some of the nonpoint source load reduction can be attributed to improved Jefferson and Clear Creek county management practices for road maintenance, construction practices, stormwater controls and land use controls. This 2018 nonpoint source phosphorus loading was heavily influenced by the spring runoff period.

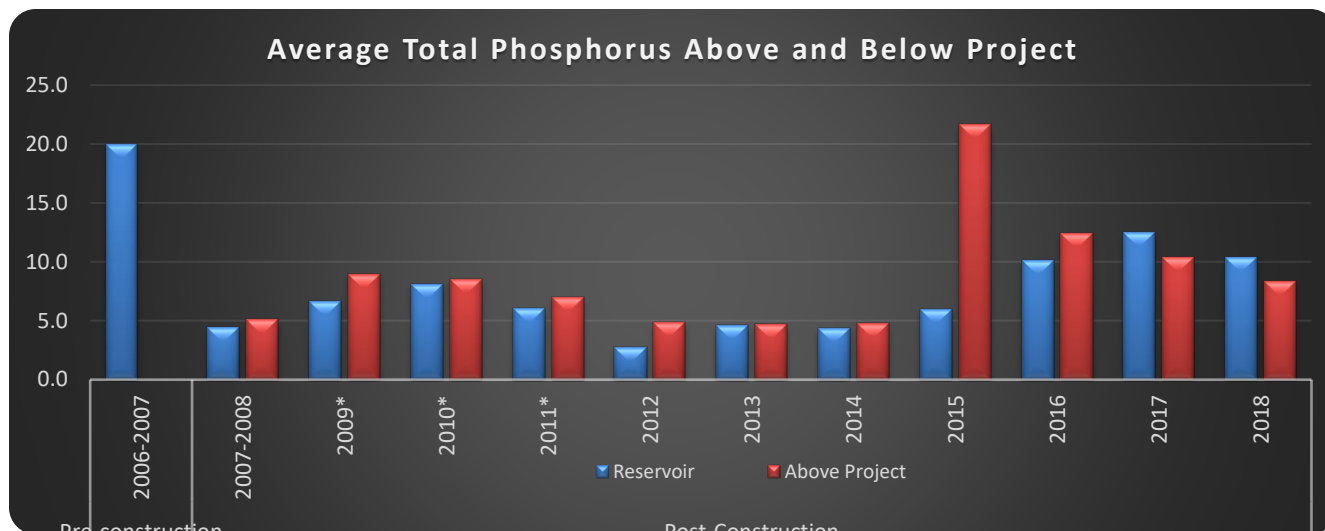
Figure 6 Total Phosphorus Reduction at Coyote Gulch Restoration Site

There was no active total phosphorus trading by Association membership in 2018 (See Table 23 in the *BCWA 2018 Annual Report* for a status of trading activity summary). The Association has established four trading policies to improve future trading programs (*BCWA Policy 1 Trading Program*, *BCWA Policy 19 Nutrient Trading Program Eligibility*, *BCWA Policy 26 Point to Point Trade Administration*, and *BCWA Policy 35 Membership Entity Termination and Permit Closure*). The Association Coyote Gulch Restoration Project has established the annual available total phosphorus trade pounds consistent with the Association trade program at 78 pounds (*BCWA TM 2016.03 Coyote Gulch Summary*). The project has effectively reduced total phosphorus loading by about 75% on an annual basis (Figure 6).

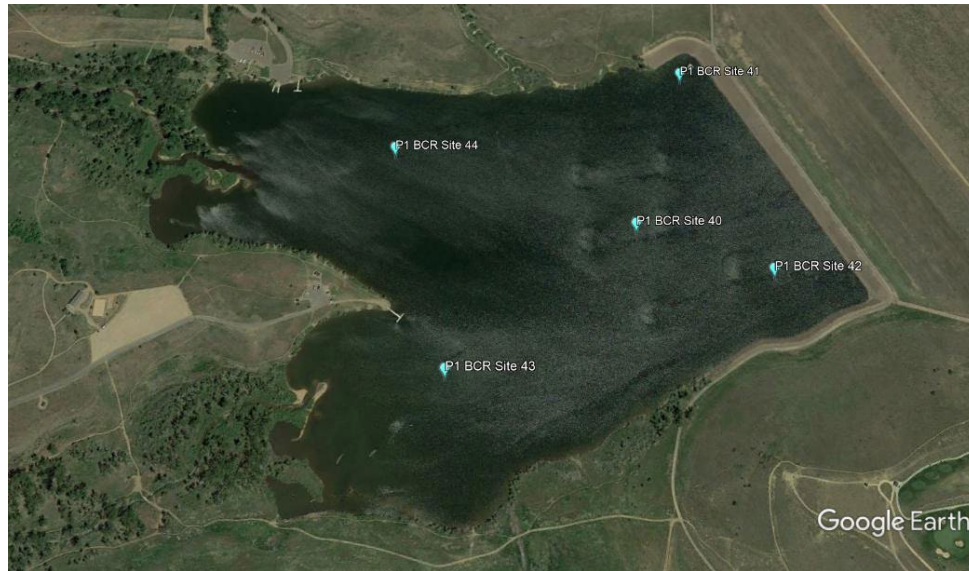
Figure 8 Reservoir Monitoring Stations; Site 40 is the Routine P1 Station (2018 image)

The routine monitoring program (P1) focuses on Turkey Creek drainage and Bear Creek drainage inputs, and discharge from Bear Creek Reservoir into lower Bear Creek with a central pool characterization of the reservoir near the dam (Figure 8; BCWA site 40). The outlet structure is near BCWA site 41 with Bear Creek inflow near BCWA site 44 and Turkey Creek inflow near BCWA site 43 (Site 43 and site 44 were not monitored in 2018). The reservoir chemistry and biological characterization monitoring occurs at BCWA site 40. Vertical probe samples for specific conductance, temperature, dissolved oxygen, and pH measured at ½ and 1-meter intervals at all reservoir sites. The current monitoring program optimizes data generation to evaluate reservoir inflow

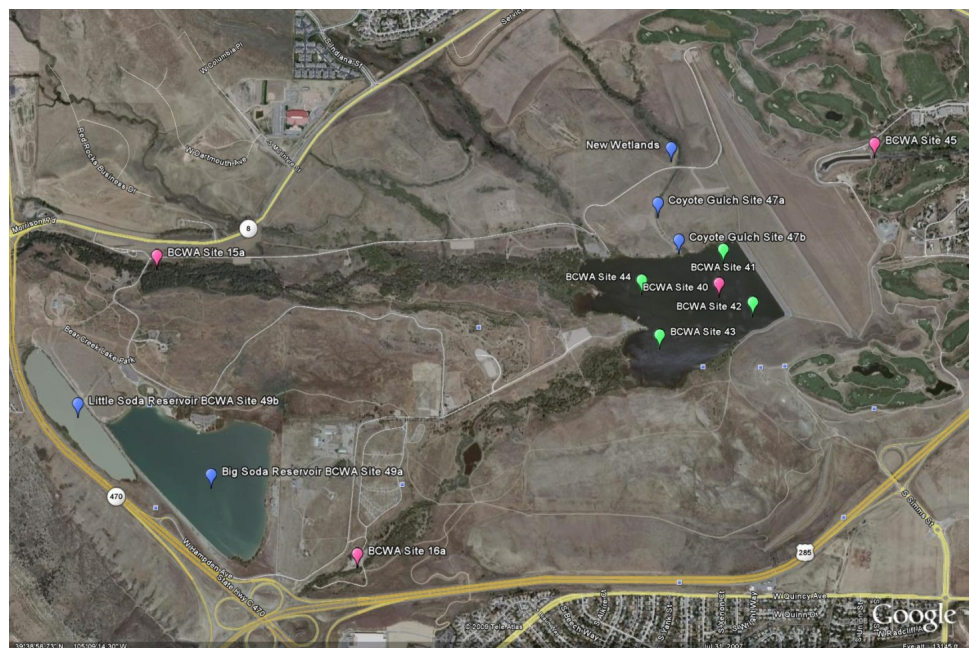
Figure 9 Monitoring Stations (Active and Historic) in Bear Creek Lake Park

loading, chemical and biological changes within the reservoir, and reservoir outflow, while minimizing monitoring cost. Figure 9 shows all active and historic monitoring stations within Bear Creek Park. The Association maintains maps of recent and historic sampling sites, wastewater treatment plant locations and special study areas in the Association's electronic watershed plan.

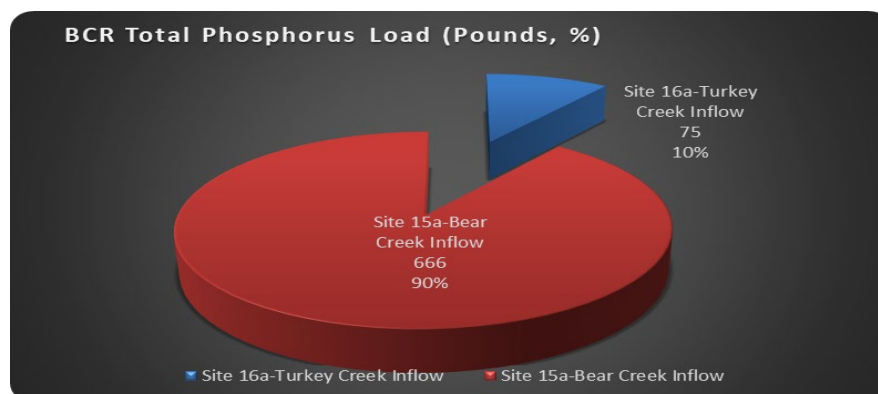
Figure 15 Estimated Total Phosphorus loading into Bear Creek Reservoir

The watershed-monitoring program characterizes nutrient loading into Bear Creek Reservoir from two primary drainages: Bear Creek and Turkey Creek. The Association monitors for total phosphorus and total nitrogen monthly. The Association has established preferred management strategies for Bear Creek Reservoir (*BCWA Policy 20*). The total phosphorus load from the watershed comes from a combination of wastewater treatment plant point source loads, un-regulated point sources, and nonpoint sources, including runoff. There are over 9,000 septic systems in the watershed. The estimated total phosphorus load in 2018 from all sources reaching the reservoir was 741 pounds at a flow of about 7,000 acre-feet. Bear Creek drainage contributed 90% of the TP load (Figure 15). The management program targets reduction of total phosphorus reaching the reservoir on an annual basis. Figure 16 shows the total phosphorus reservoir trend.

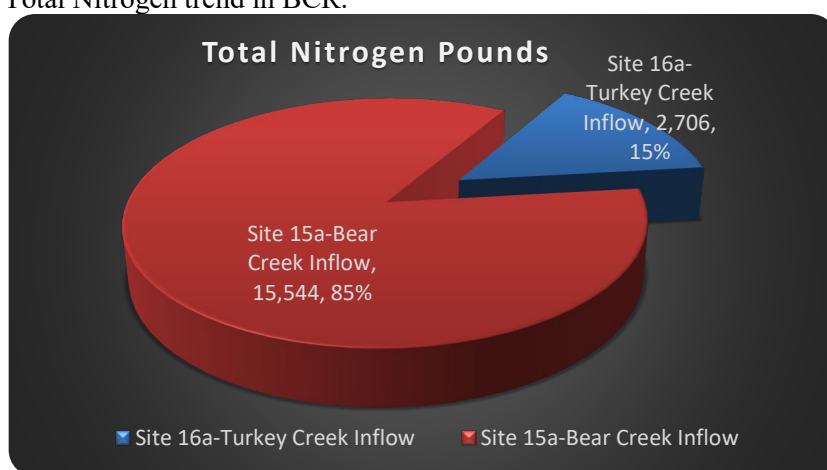
Figure 17 Total Nitrogen Loading into Bear Creek Reservoir

The total nitrogen loading (Figure 17, about 48,410 pounds) had 85% of the load coming from Bear Creek. Figure 18 shows the Total Nitrogen trend in BCR.

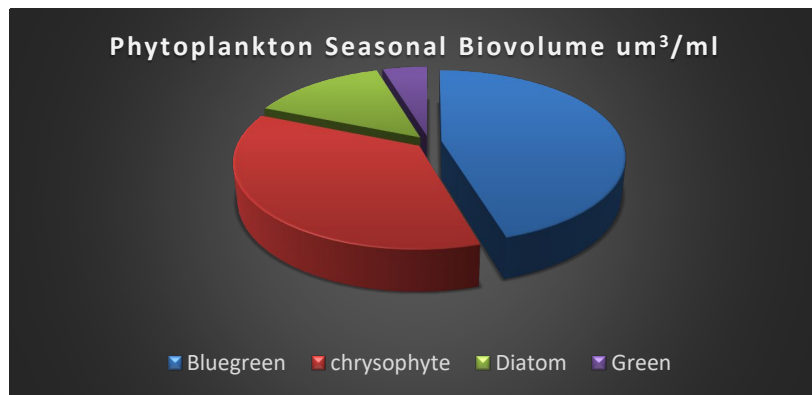
**Figure 19 Bear Creek Reservoir Phytoplankton Biovolume**

summarizes the phytoplankton data. Figure 19 shows the phytoplankton species diversity during summer sampling period. Figure 20 shows the general clarity trend in the water column using Secchi measurements. May through October had the poorest clarity caused by runoff.

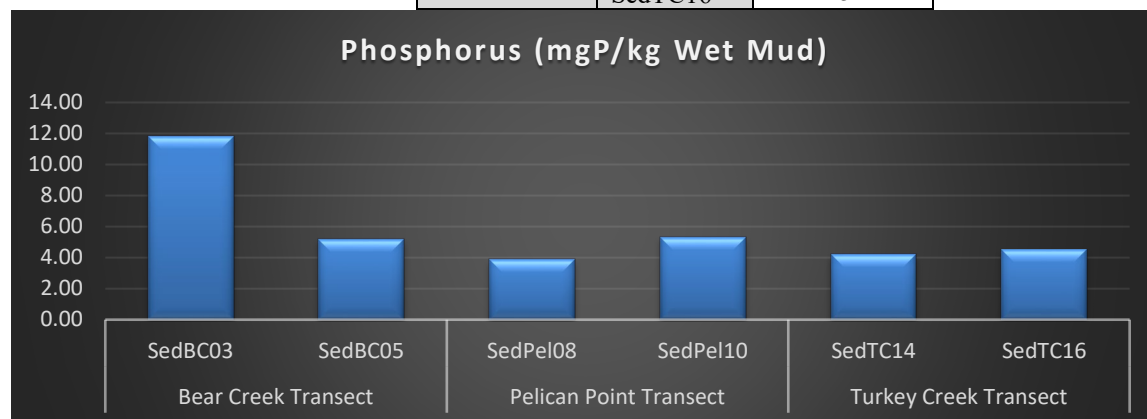
Figure 26 Sediment Phosphorus by Transect in BCR

mgP/kg Mud
Bear Creek Transect	SedBC03	11.82
	SedBC05	5.21
Pelican Point Transect	SedPel08	3.86
	SedPel10	5.33
Turkey Creek Transect	SedTC14	4.20
	SedTC16	4.51
