Technical Memorandum BCWA

Date: February 8, 2019
To: Bear Creek Watershed Association
From: Russell N. Clayshulte, Manager
Re: BCWA TM 2018.02 UBCW Summary

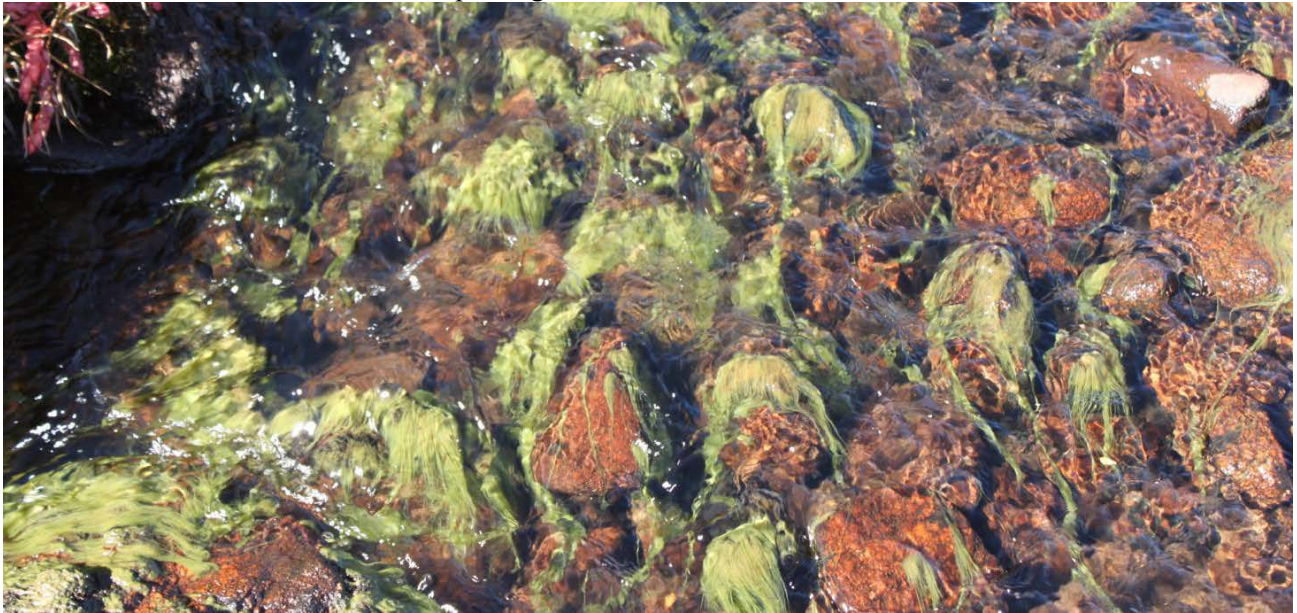
Figure 2 Excessive periphyton growth on hard substrate in Bear Creek

In 2009, the BCWA established sites 36 and 37 at Summit Lake. The phosphorus and nitrogen data in 2009 exceeded the expected conditions for an ecoregion II environment. The BCWA was particularly surprised by the high total ammonia concentrations. This data resulted in the BCWA conducting a more detailed investigation of the site. The BCWA also researched fens, atmospheric depositions and other natural causes. The BCWA made observations of the periphyton coverage on hard substrate within Bear Creek down to site 37. These observations showed an excess of periphyton beyond normal expectations, which strongly suggested nutrient enrichment (Figure 2). It was field observations that help suggest the origin of pollutants came from the vicinity of the parking lot and wastewater holding vaults. Association observations suggest that one origin of the pollutants was the new/old toilet vaults at the Summit Lake parking lot

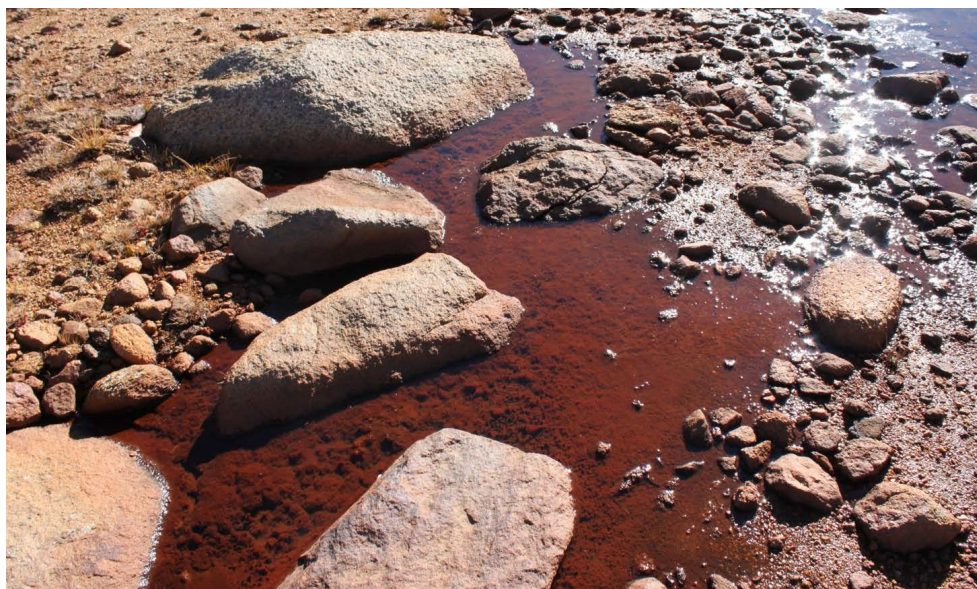
The preliminary data analyses from just visually tracing high algal productivity in the fen ponds showed extremely elevated nutrients, that were higher than found anywhere else in the watershed (Figure 3). In 2013, measurements from only a single estimated emergent point of the plume had a seasonal average total phosphorus of 1,801 ug/l (maximum 4,112 ug/l), with a conservative estimate of 129 pounds/month discharged into upper Bear Creek (potentially over 400 pounds in the warm season). That is potentially more total phosphorus discharged into Bear Creek than 10 out of 16 wastewater treatment plants discharge in an entire year. Denver Parks and Recreation in 2013 repaired the new vaults and the 2014 water quality data suggests this helped resolve part of the nutrient loading.

Figure 3 Excessive red algal growth typical in fen ponds along the suspected pollutant plume flow

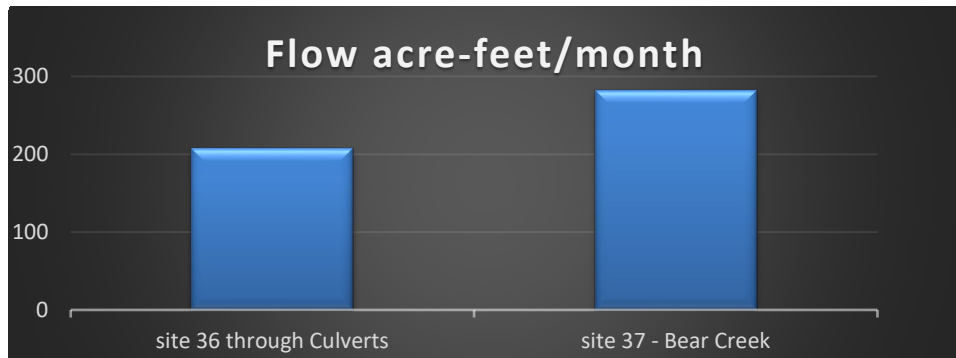
Figure 4 Monthly estimated flows

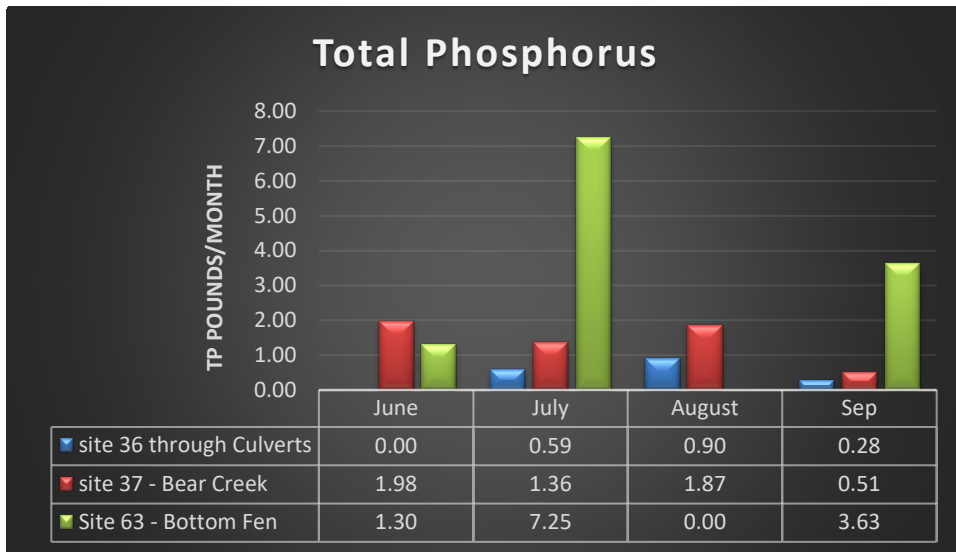
Figure 5 Total Phosphorus Loading

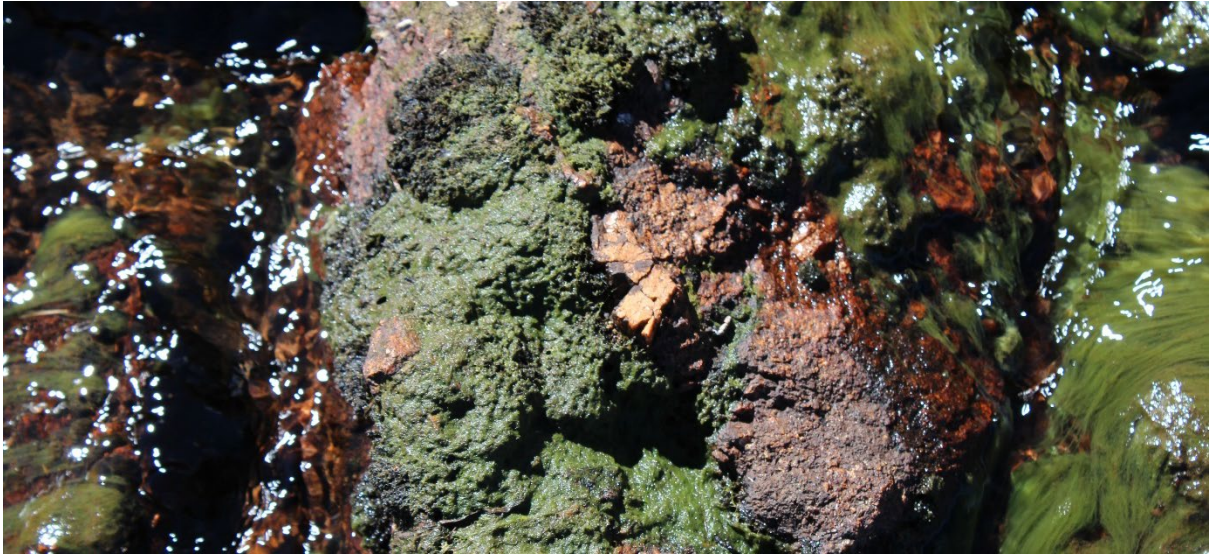
Although the fen plume monitoring site continues to produce an elevated phosphorus loading, this load is not reflected in the concentrations and load measured at site 37. This indicates that algal productivity is consuming much of the nutrient load prior to this monitoring site (Figure 7). Most of the recent algal growth appears to be several species of green algae. There does continue to be a potential problematic bluegreen algae that may be associated with the observed fish kills. Almost all of this algal mat material will die over the winter and flush downstream in the spring runoff. As such, the nutrient load gets flushed downstream as organic matter.

Figure 7 Algal growth in Bear Creek upstream of site 37
